**Produced water and hydrocarbon releases at the Osage-Skiatook petroleum  
environmental research sites, Osage County, Oklahoma:  
Introduction and geologic setting**

James K. Otton and Robert A. Zielinski  
U.S. Geological Survey  
Denver, Colorado 80225  
Voice: 303-236-8020  
FAX: 303-236-0459

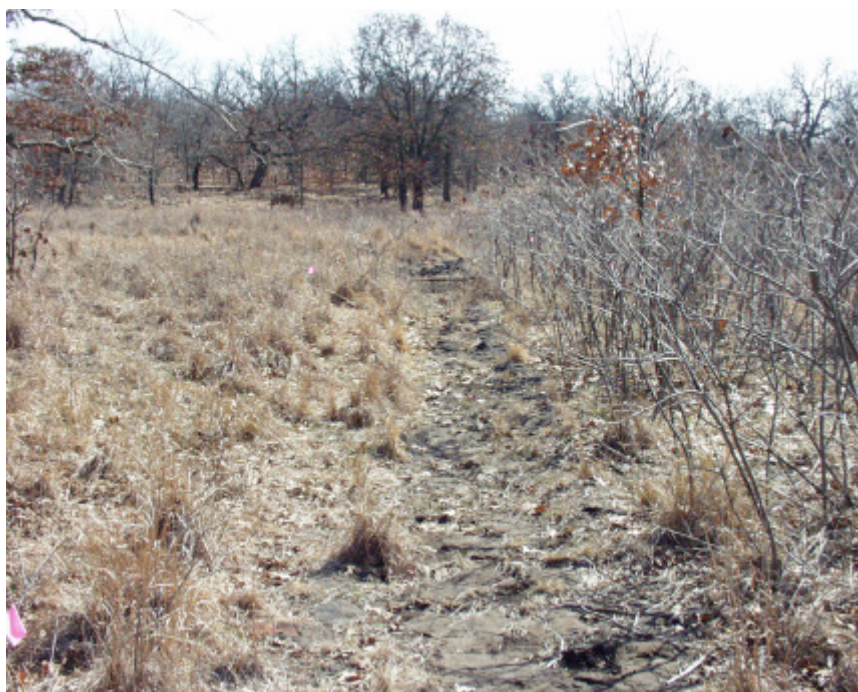
A narrow corridor of weathered asphalt extends from the area around the two tanks north to two unlined pits (A and B, figure 4). This feature follows an unlined trench (figure 5) that appears to have been designed to carry produced fluids from the two redwood tanks to the pits. This trench cuts across the natural topographic slope, which is northwest on this part of the site. The channel splits just upslope from the two pits with one branch leading to each pit. A badly corroded pipe exits pit A through its northern berm, and this pipe likely served to allow oil to be pumped from the pit into a tanker truck. The main channel changes direction about halfway between the tank area and the pit area and it appears that oil overtopped the channel at this point and spilled onto adjacent soils (figure 4). Pit A contains tarry or asphaltic hydrocarbon (figure 6) on which no vegetation grows. Oak trees lie to the east of the pit and a large, isolated oak tree grows just to the north of the pit berm (figure 6). Pit B is located to the west and shares a common berm with Pit A (figures 4, 7). This pit contains weathered asphalt. Sparse grasses grow on much of the surface. Water ponds at the low (north) end of the pit after rainfall. Two small, low areas occur west and southwest of the two pits (figure 4). During wet weather, the ground in these low areas is water saturated.

Figure 5- Trench with weathered asphalt between redwood tanks and pits (looking south upslope towards the location of the tanks). Note the sumac with one or two small oaks to the right and the mature oak forest in the background.

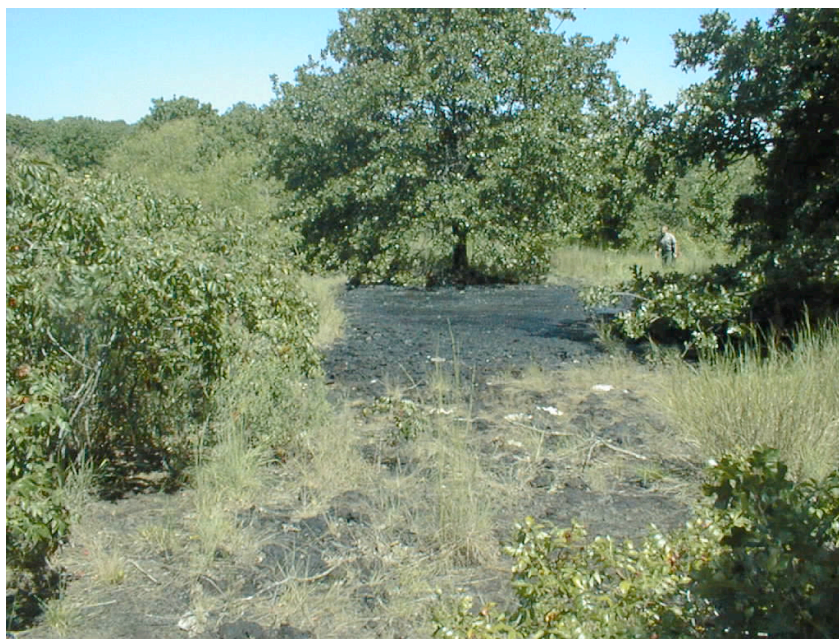
Figure 6- Pit "A" with asphaltic hydrocarbons.

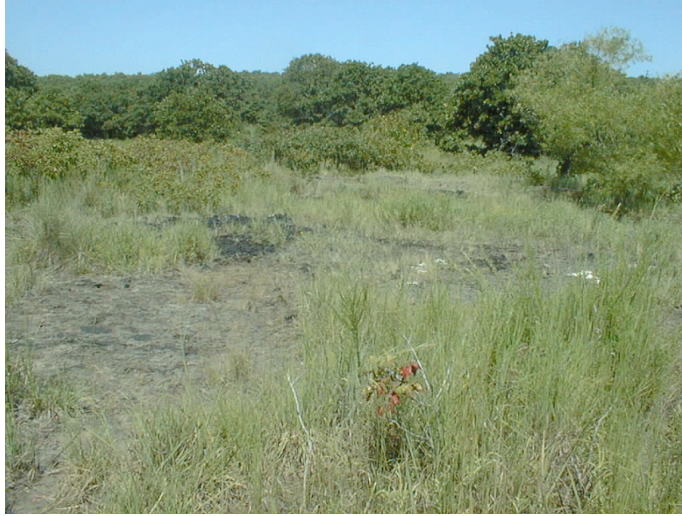
Figure 7- Pit “B” with highly weathered hydrocarbons and sparse grasses. The photographer is standing on the berm between the two pits. The north edge of the pit berm is to the upper right. A willow tree grows just beyond this berm (see Figure 4), sumac is growing beyond the pit to the left.

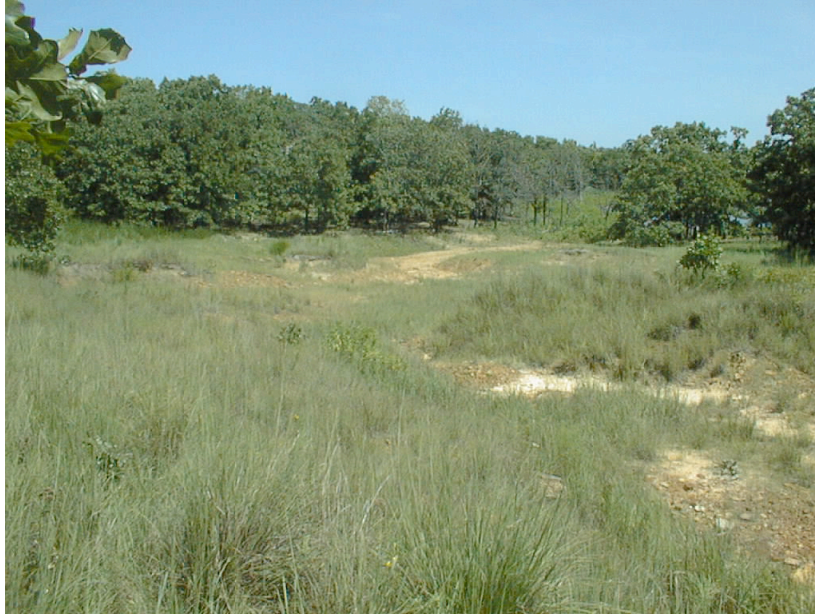
North of the road is an area of deeply eroded and disturbed soils (figures 4, 9). Sparse grasses grow except where the soil salt content is high. The deeply eroded section is largely delineated by a terrace edge (figure 4). Much of the section of disturbed soils (figure 4) is oriented approximately east-west across the south-central part of the area north of the road. Features on the 1937 aerial photo for the site suggest that this is the trace of an older road. The road was apparently moved southward as headward erosion of two gullies impinged on the roadbed. Three soil pedestals, in which the pre-erosion soil profile is preserved, occur within the deeply eroded section (see small, irregular hachured areas in figure 4; two pedestals are shown in figure 10). They are capped with grasses and forbs. A small oak tree grows on one pedestal. A small promontory on which two oak trees are growing extends into the deeply eroded section from the southwest. The area is drained by several washes that coalesce to the north before leaving the site. Flow occurs in these drainages only after rainfall, although it may persist for several days in the drainage at the north edge of the site (figures 4,10). Bedrock, including three outcrops of resistant sandstone ledges, is exposed in the deeply eroded section. A small wet soil area occupies the west corner of the deeply eroded section (figure 4).

Figure 9- The deeply eroded area, August 2000, from near the road looking north.

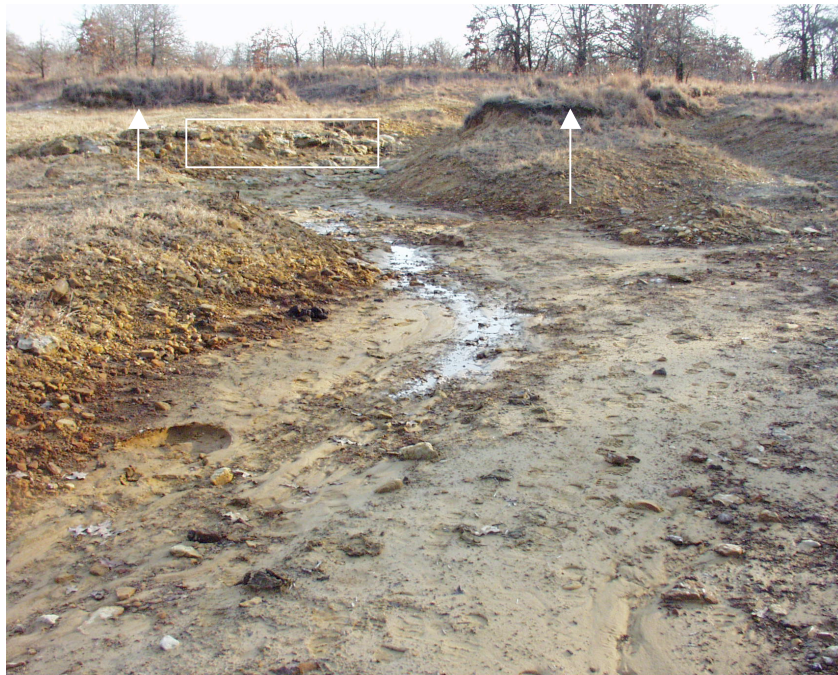
Figure 10- Surface flow disappearing below the surface of the stream alluvium within the deeply eroded area, March 10, 2001. Two soil pedestals are delineated by arrows (right and left). Sandstone bedrock outcrop is delineated by a rectangle.

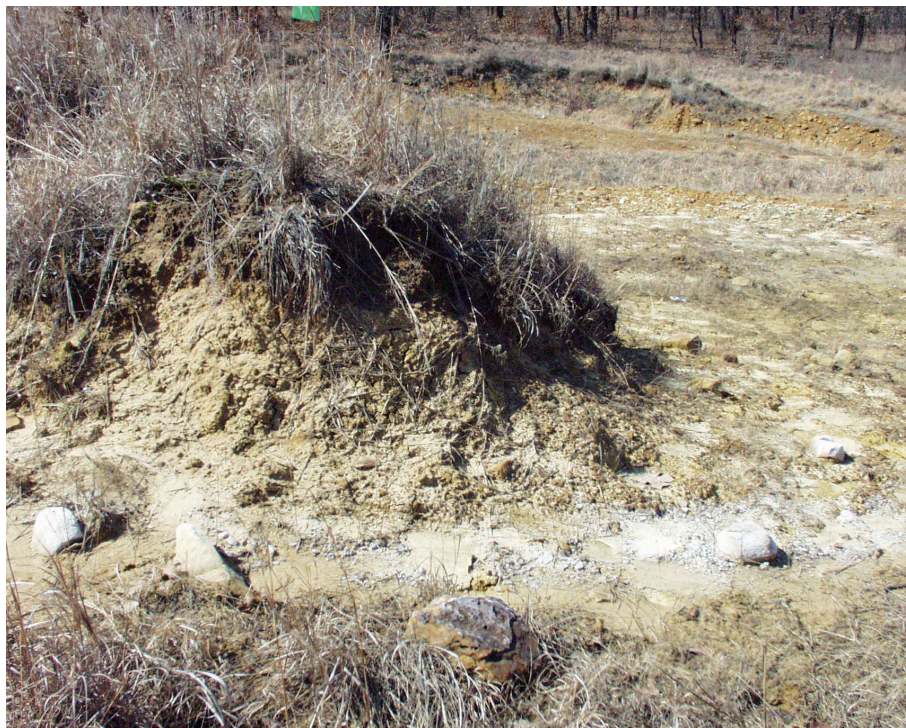
Effluorescent salt crusts are observed at various times of the year. They commonly occur on the lower part of the central sandstone outcrop (figure 4, north central part of deeply eroded area) and on the surface of the alluvium along the channel below the central outcrop. Salts also are common around the soil pedestal in the south-central part of the deeply eroded area (figure 11).

Figure 11- Salt effluoresence adjacent to soil pedestal.

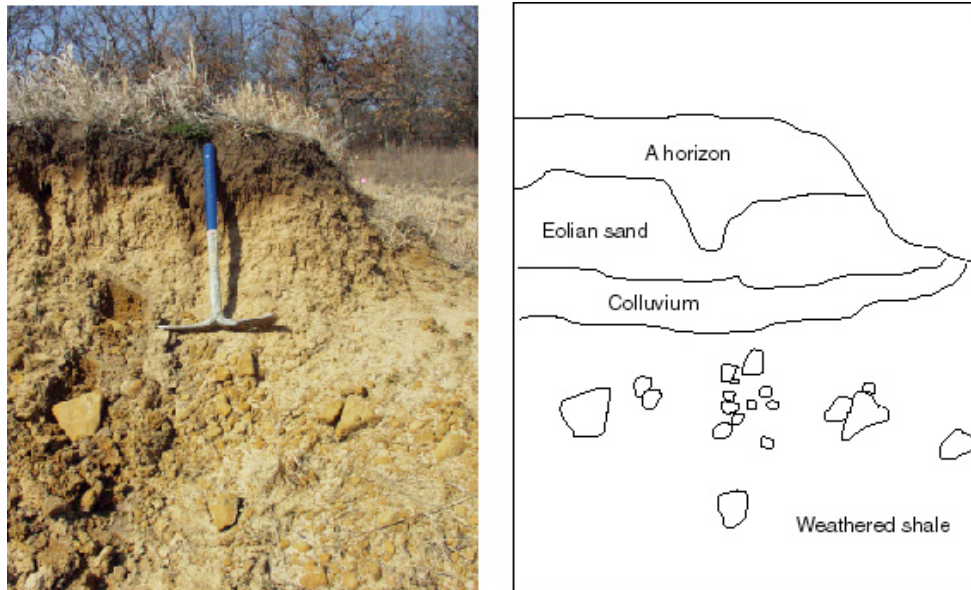
Figure 16- Stratigraphic section exposed in a soil pedestal within the deeply eroded area. The pick is 0.65m (2.15 ft) long. Sandstone clasts below the pick are eroded from the colluvial layer.

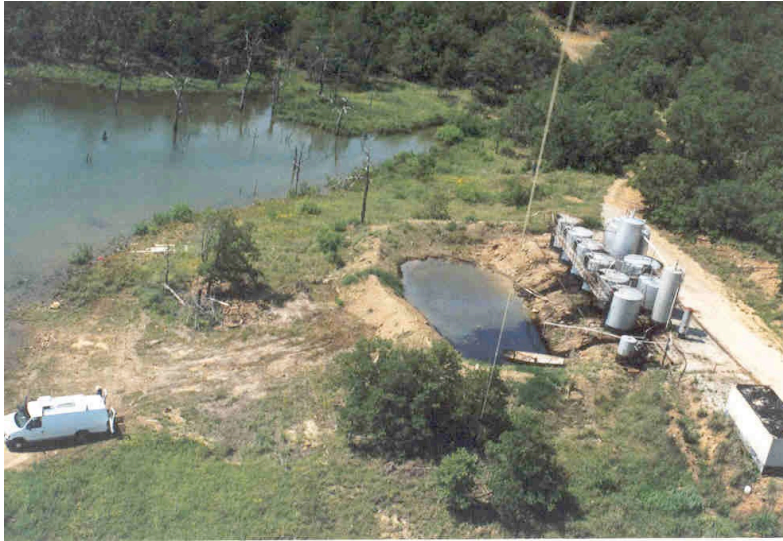
At least three tank batteries have been constructed at this site. An active tank battery and adjacent pit about 26 m across occur in the south part of the site. A salt scar extends from the east edge of the pit berm down to the lake (figure 18, 19). An old tank battery site, presently (2002) marked by a flat graded area with some piles of rubble,

The salt scars below the 3 tank batteries were remediated in the fall of 1999 by removing 15 cm (6 inches) of salty surface soil, replacing it with clean soil, covering the areas with straw, and seeding with winter wheat (G. Berschue, U.S. Army Corps of Engineers, 2001, oral commun.). Salt crusts are common on the remediated areas and have also been observed in a barren patch of saline ground near the lake's edge (figure 18). Growth of planted grasses was reasonably successful the first growing season (2000), but most of the grasses have since died, especially below the active pit.

Figure 19- Aerial view of the active tank battery, pit, salt scar, and Skiatook Lake. The lake level is above the normal pool elevation. Photo by Ken Jewell, U.S. Environmental Protection Agency, Ada, Oklahoma.
